# Manhole Inspection Summary

Manhole # S39Y1\_011MH

Insp Date: **6/23/08 2:27 PM**

**Location** Address: **433 E. Patapsco Ave.**

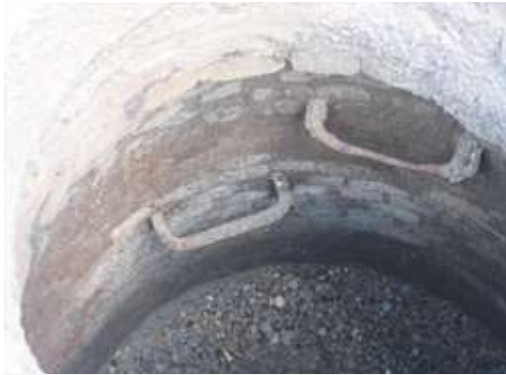
Steps

Count: **4** Missing: **1** ☒ **Corroded**

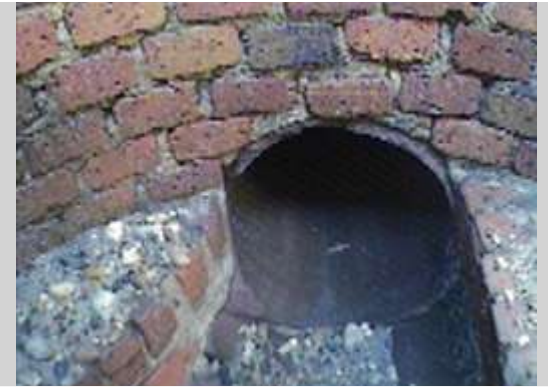
12 O'Clock Outflow

12 in. Circular Gravity Sewer  
Pipe Out @ 12 O'Clock

Pipe Height: **12** (in.) Rod and Bar (Angled)  
Pipe Material: **Unknown** ☐ Pipe Lined  
Invert Depth: **6.80** (ft.) Flow Characteristics: **Slow**  
Deposits: ☐ None ☐ Mud ☐ Sludge ☒ **Debris** ☐ Grease  
Silt Depth: **4** (in.) Deposits Extent: **Medium**  
Infiltration: **None** Pipe Seal Cond: **Sound**

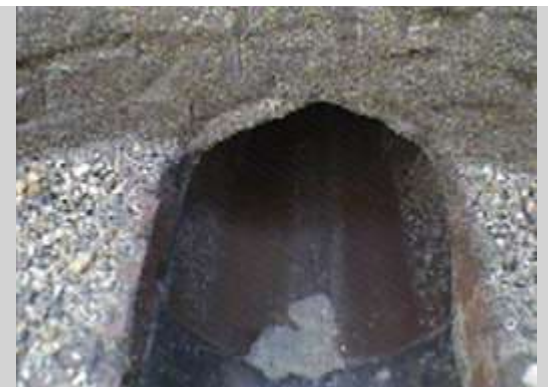
6 O'Clock Inflow

12 in. Circular Gravity Sewer  
Pipe In @ 6 O'Clock

Pipe Height: **12** (in.) Rod and Bar (Angled)  
Pipe Material: **Unknown** ☐ Pipe Lined  
Invert Depth: **6.78** (ft.) Flow Characteristics: **None**  
Deposits: ☒ None ☐ Mud ☐ Sludge ☐ **Debris** ☐ Grease  
Silt Depth: (in.) Deposits Extent:  
Infiltration: **None** Pipe Seal Cond: **Sound**

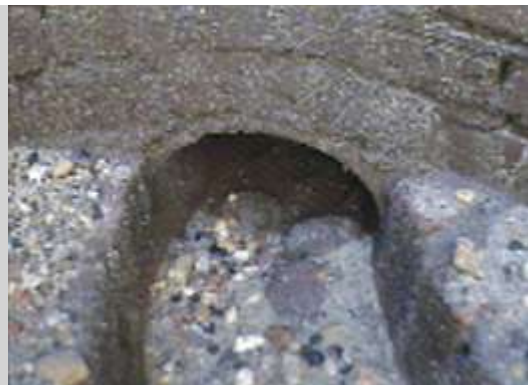
9 O'Clock Inflow

8 in. Circular Gravity Sewer

Pipe In @ 9 O'Clock

Deposits: ☐ None ☐ Mud ☐ Sludge ☒ **Debris** ☐ Grease

Silt Depth: **3** (in.) Deposits Extent: **Medium**
